# RESEARCH MEMORANDUM

DE-ICING AND RUNBACK CHARACTERISTICS OF THREE CYCLIC  
ELECTRIC, EXTERNAL DE-ICING BOOTS EMPLOYING  
CHORDWISE SHEDDING

By Robert S. Ruggeri

**NACA RM E53C26**

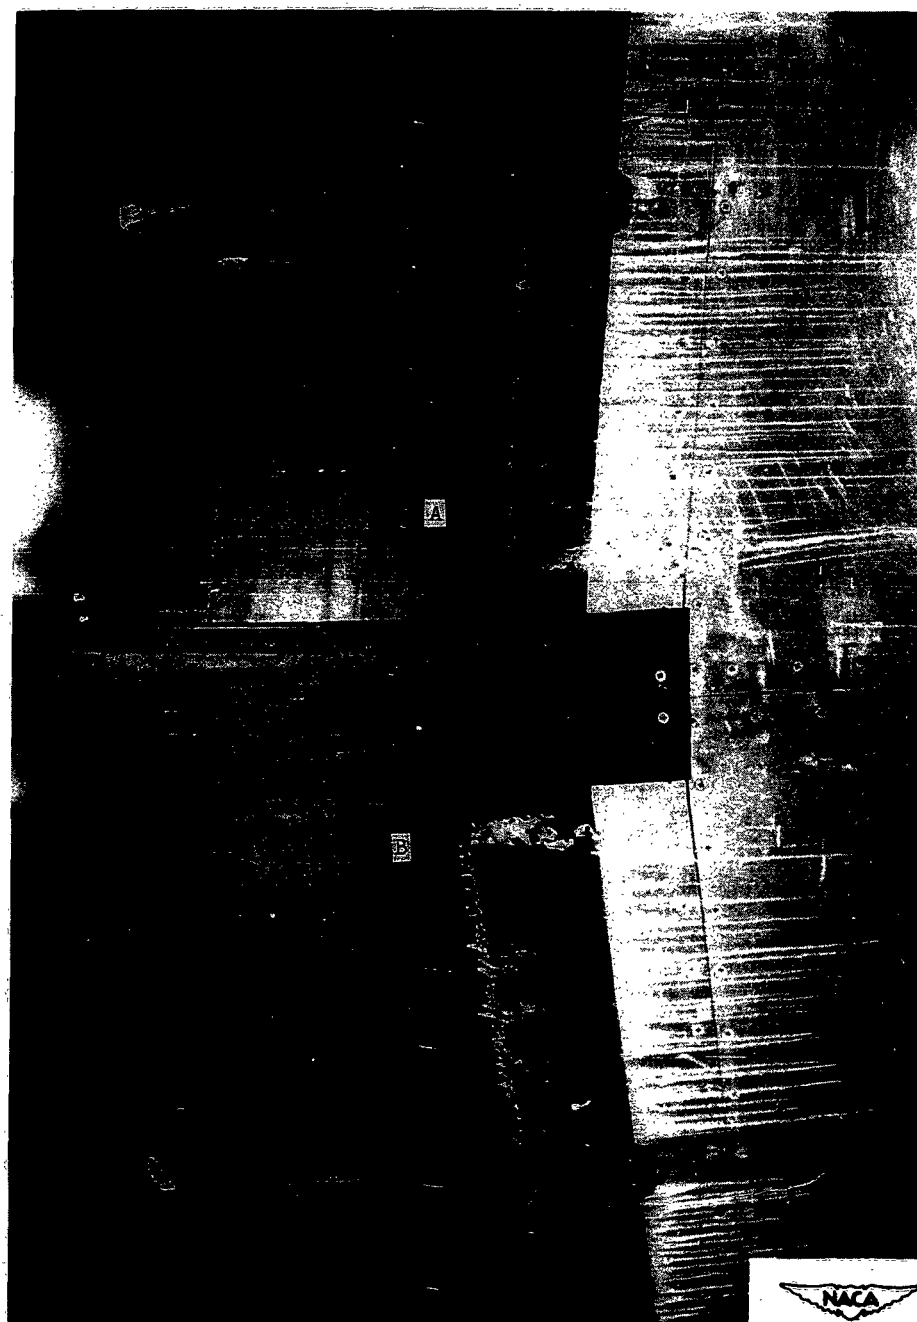
(a) Upper surface.

Figure 15. - Runback pattern obtained on boots A and B after 32 minutes in icing. Free-stream total temperature,  $20^{\circ}$  F; free-stream velocity, 288 feet per second; liquid-water content, 0.66 gram per cubic meter; droplet diameter, 14 microns; angle of attack,  $2^{\circ}$ ; heat-on time, 10.0 seconds; design power densities.

(b) Lower surface.

Figure 15. - Concluded. Runback pattern obtained on boots A and B after 32 minutes in icing. Free-stream total temperature, 20° F; free-stream velocity, 288 feet per second; liquid-water content, 0.66 gram per cubic meter; droplet diameter, 14 microns; angle of attack, 2°; heat-on time, 10.0 seconds; design power densities.

The runback pattern obtained on boots A and B after 32 minutes of operation in icing at the lowest value of free-stream velocity investigated (288 ft/sec) is presented in figure 15. The runback pattern was obtained in an icing condition having a free-stream total temperature of  $20^{\circ}$  F, a liquid-water content of 0.66 gram per cubic meter, and a droplet size of 14 microns. The boots were operated at design power density, a heat-on time of 10.0 seconds, and an angle of attack of  $2^{\circ}$ . The runback pattern and nature of the ice formations observed on the upper and lower surfaces of both boots were found to be very similar. The runback ice was rather clear and smooth. On the lower surface, the runback ice formed a solid sheet approximately  $1/4$  inch thick for a distance of approximately 3 to 4 inches behind the heated area before changing into a rivulet-like formation which extended back an additional 4 to 8 inches. On the upper surface of the airfoil, the runback ice was approximately  $1/8$  inch thick with thin rivulet-type ice formations extending as far back as 12 inches behind the heated area.

As can be noted from a comparison of figures 14 and 15, the effect of decreasing speed in a given icing condition is an increase in chordwise extent of runback icing, with a corresponding decrease in runback ice thickness. Although figures 14 and 15 present runback patterns obtained in different icing conditions, the conditions are not so different as to preclude a comparison or an effect due to changes in free-stream velocity.

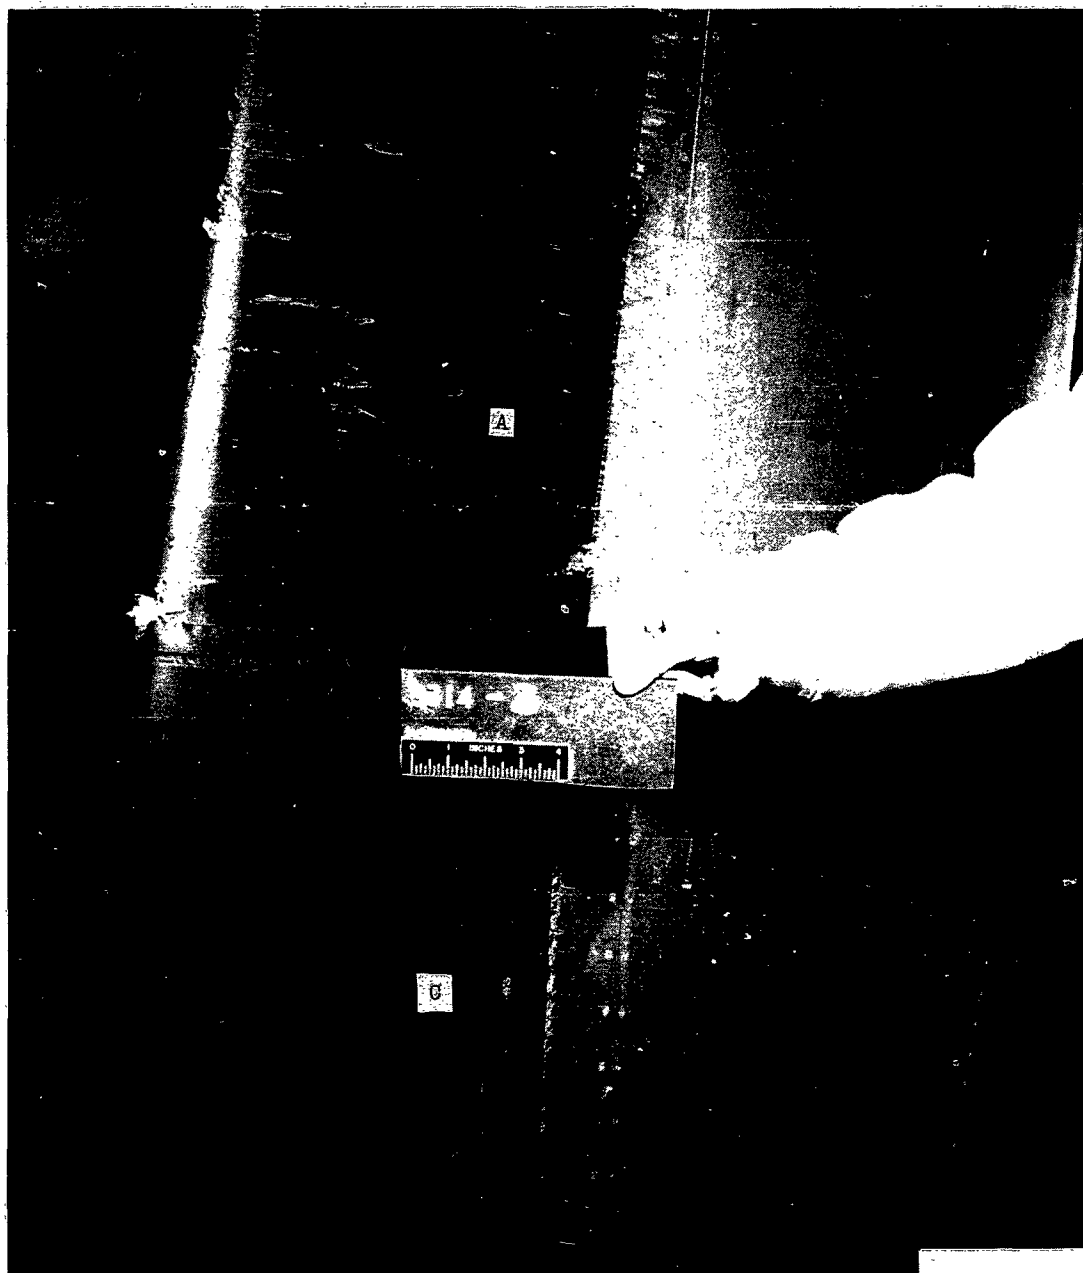
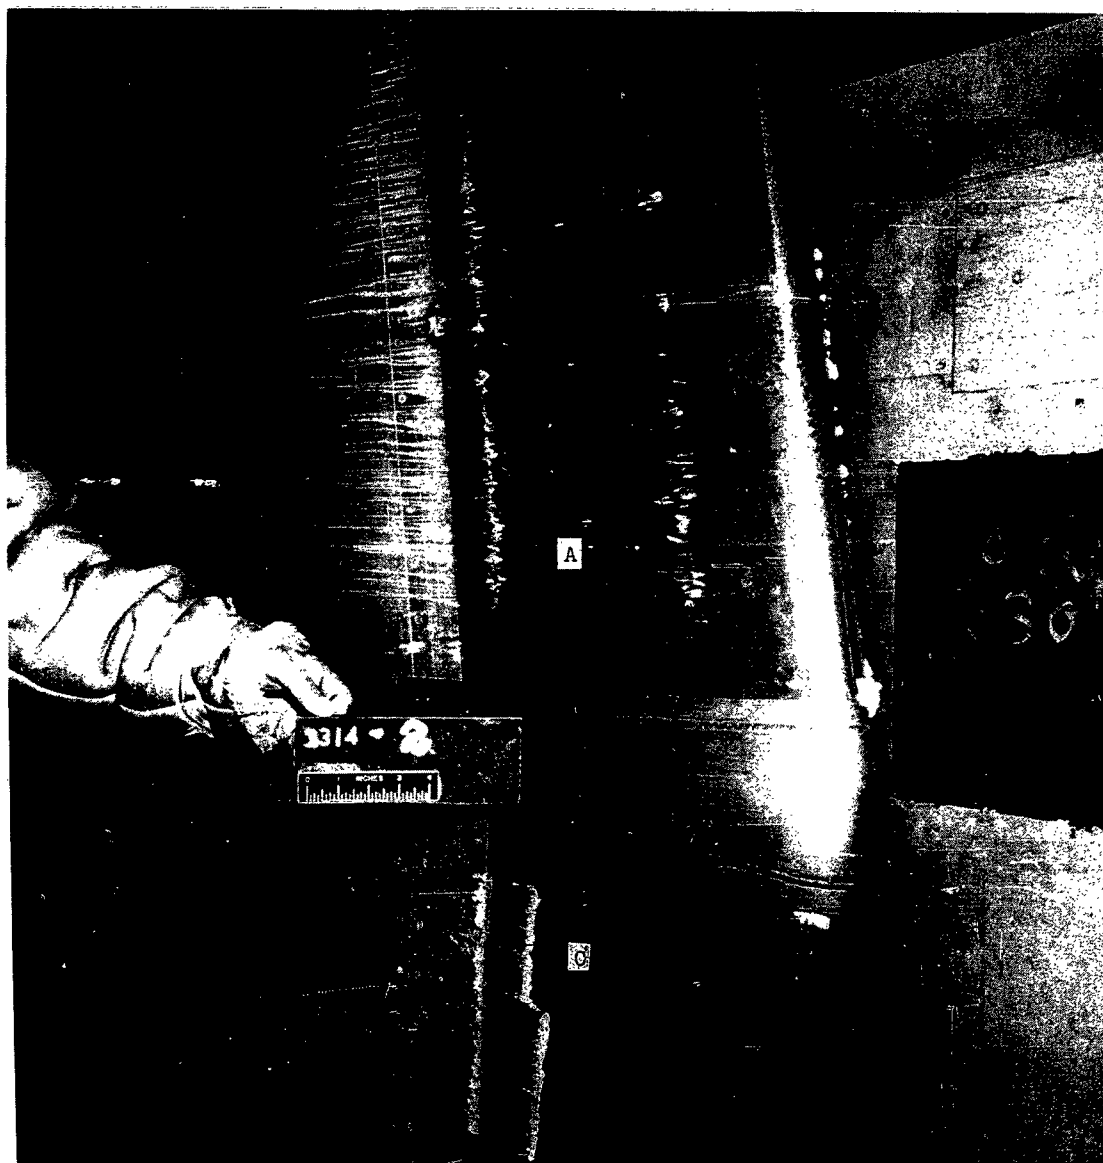
(a) Upper surface.

Figure 16. - Runback pattern obtained on boots A and C after 32 minutes in icing. Free-stream total temperature, 20° F; free-stream velocity, 397 feet per second; liquid-water content, 0.55 gram per cubic meter; droplet diameter, 14 microns; angle of attack, 2°; heat-on time, 10.3 seconds; design power densities.

(b) Lower surface.

Figure 16. - Concluded. Runback pattern obtained on boots A and C after 32 minutes in icing. Free-stream total temperature, 20° F; free-stream velocity, 397 feet per second; liquid-water content, 0.55 gram per cubic meter; droplet diameter, 14 microns; angle of attack, 20; heat-on time, 10.3 seconds; design power densities.

The runback pattern obtained on the upper and lower surfaces of boots A and C after 32 minutes of operation in an icing condition similar to that presented in figure 14 is shown in figure 16. The runback pattern was obtained in the following icing condition: free-stream total temperature,  $20^{\circ}$  F; liquid-water content, 0.55 gram per cubic meter; droplet size, 14 microns. The boots were operated at design power densities, a heat-on time of 10.3 seconds, and an angle of attack of  $2^{\circ}$ . For boot A, runback ice occurred on the aluminum skin behind the boot trailing edge; whereas, for boot C, the runback ice is confined to the scarf area. This apparent difference in runback pattern is probably due to the difference in design of the scarf area of the two boots. The scarf of boot A tapers from  $1/8$ -inch thickness just behind the heated

area to almost a feather edge at the trailing edge of the boot. Boots A and B are designed to be mounted onto the basic airfoil, whereas boot C is designed so that, when mounted on the airplane, the outer surface of the boot is flush with the basic airfoil contour. For this investigation, boot C was cemented onto the leading edge of the airfoil model, and, hence, a sharp step-off of 1/8 inch existed at the trailing edge of the boot. If this difference in trailing-edge design did not exist, it is probable that the runback obtained on boot C would be very similar to that obtained for the other two boots.
